# Manhole Inspection Summary

Manhole # S35A\_\_032MH

Insp Date: **11/14/08 10:38 AM**

**Location** Address: **610 w calvert st**

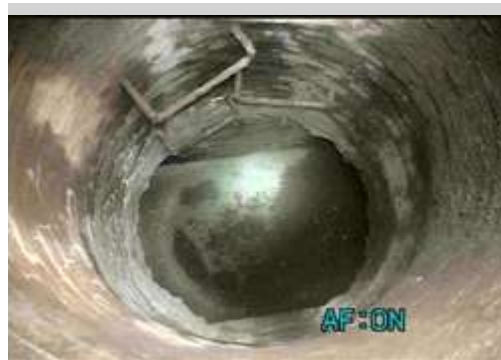
Top View

pipes are under ledge

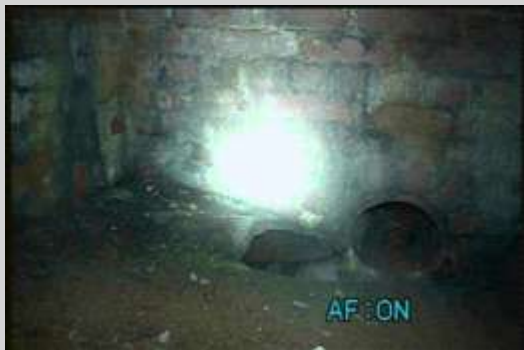
12 O'Clock Outflow

The 12 is below the light, Cant get better pic  
pipes are way under a ledge

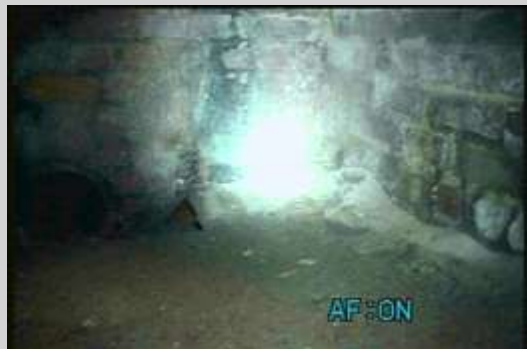
6 O'Clock Inflow

bench debris, pipe enters on far right, below flash from camera. Under ledge.
